# Duct Cutting: MULETAPE® vs. Rope

## Burn Through: The Case for MULETAPE® vs. Rope

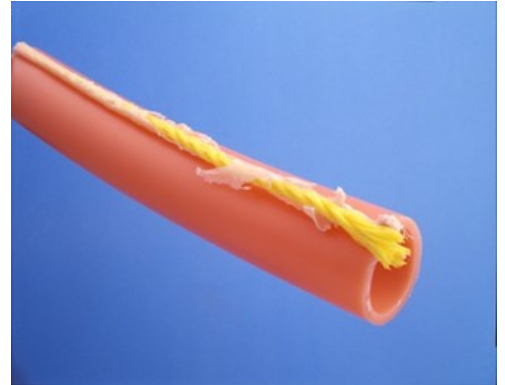
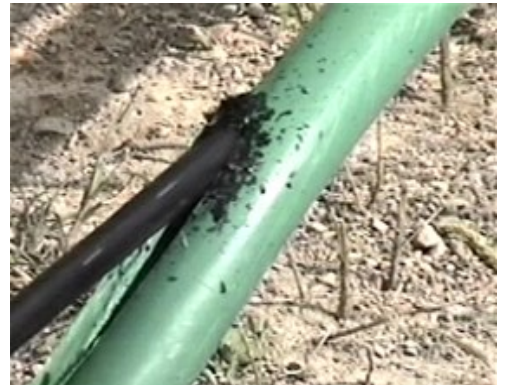
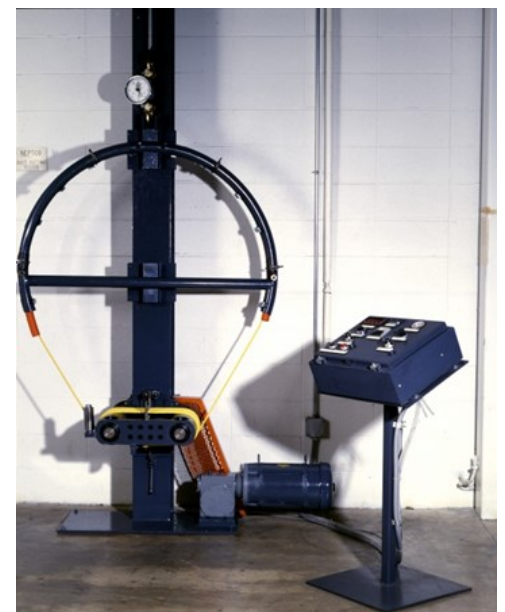
**NEPTCO Duct Cut Tester**

**A:** NEPTCO has gone to great lengths to test this theory by duplicating installation conditions in the lab and in the field. Our research engineers designed the Duct Cut Tester to evaluate the performance of various conduit materials and winch lines under typical installation conditions.

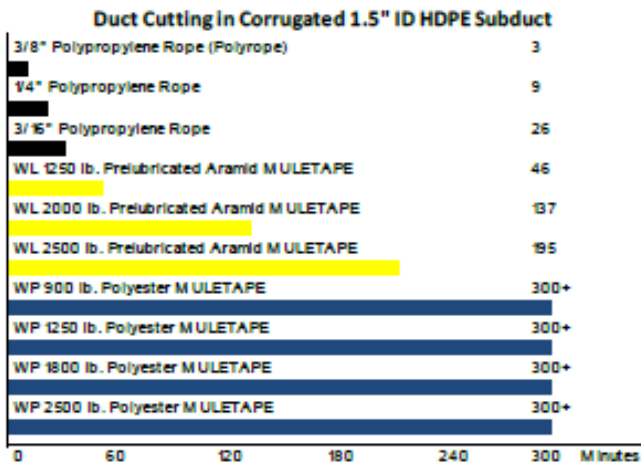
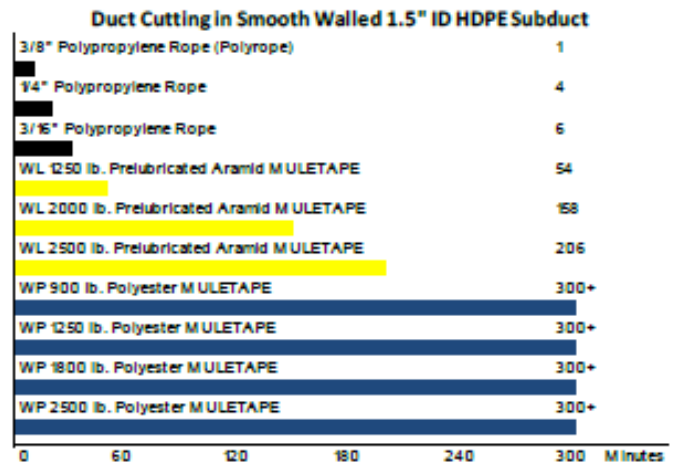
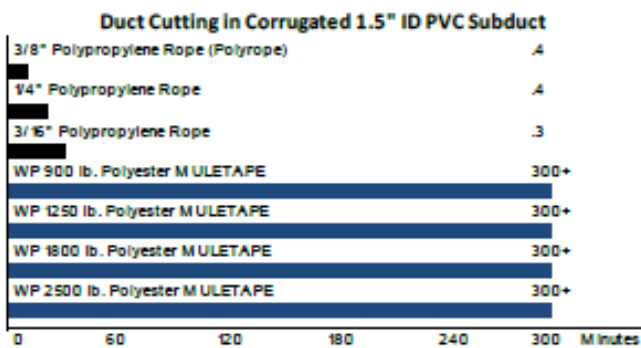
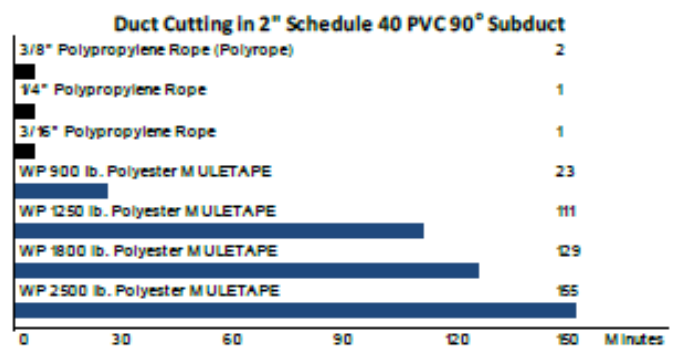
The charts below indicate the time elapsed before conduit experiences damage due to burn through:

The results tabulated on the reverse side of this sheet are conclusive: Pre-lubricated MULETAPE out-performs polypropylene rope in every installation scenario.
